Operating Experience Weekly Summary 97-33

August 8 through August 14, 1997

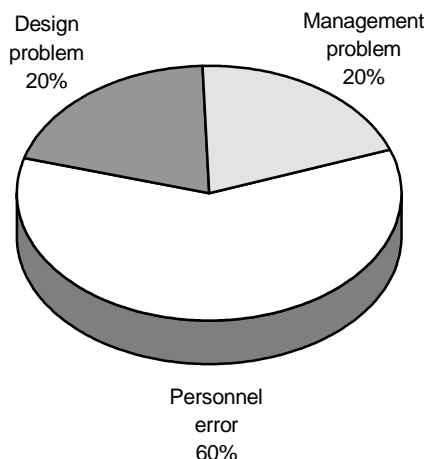
Figure 3-1. Distribution of Root Causes for Contacting Guy Wires¹

OEAF engineers reviewed the Occurrence Reporting and Processing System (ORPS) database for events involving contact with guy wires and found 11 applicable reports DOE-wide. Figure 3-1 shows the distribution of root causes reported by facility managers for these events. Personnel error represented 60 percent of the root causes and management problems, 20 percent. Inattention to detail accounted for 60 percent of the personnel errors, and work organization/planning deficiency and inadequate supervision each accounted for 50 percent of the management problems. Because personnel problems, such as inattention to detail, accounted for the majority of the root causes, these events could have been prevented.

These events demonstrate the importance of exercising extreme caution when front-end loaders, forklifts, cranes, and other vehicles are in the vicinity of guy wires, power lines, and switchyards. Pre-job briefings, facility procedures, and training programs should emphasize the dangers associated with these types of operations. Some events have occurred while personnel were backing up motive units, indicating that operators of equipment must be aware of hazards in all directions, including above them. Equipment operators should walk down areas to identify and evaluate overhead hazards. Spotters should be used if equipment will be operated in the vicinity of any overhead hazards. In the event of downed lines, personnel should always consider them energized until proven otherwise. Even if there is no current flow, an electrical potential could exist. Personnel should remain inside vehicles that are in contact with downed lines until authorities have verified that an electrical hazard does not exist.

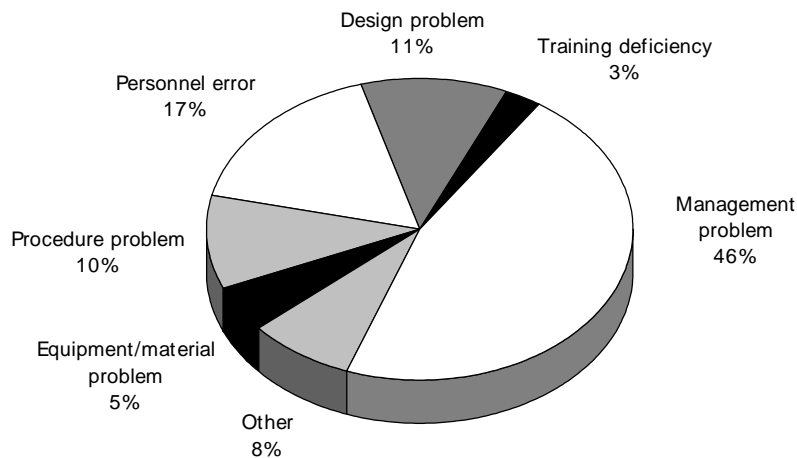
**Figure 4-1. Distribution of Root Causes for
Near-Miss Occurrences Involving Damaged Electrical Cables¹**

OEAF engineers reviewed the Occurrence Reporting and Processing System (ORPS) database and found 162 reports associated with near-miss occurrences involving cutting, damaging, or severing electrical cables. Figure 4-1 shows that facility managers reported management problems as the root cause for 46 percent of the events. Further review shows that 33 percent of the management problems were reported as work organization/planning deficiency problems. This indicates that management attention can prevent these type of events and the potential injuries associated with them.

These events underscore the importance of using effective work control practices and detailed job planning to provide multiple levels of protection. In the Hanford floor-slab event, an expert obtained to determine if buried cables were present identified a suspect area. However, a communication failure between contracting organizations resulted in the 110-volt line being severed. In the Lawrence Livermore event, drawings were reviewed, scans were performed, and the line was located before work started. However, the line was not at the depth indicated on the drawings. In the Hanford abandoned lines event, there were multiple reviews of drawings, site conditions, and scans that resulted in locating part of one line before work started. However, a second line was not detected, and the first line did not run straight as expected. No injuries occurred because both lines were de-energized, but similar events with energized lines have occurred throughout the DOE complex. Safety and health hazard analysis must be included in the work control process to help prevent worker injury. The OSHA safety requirements of 29 CFR 1926, *Safety and Health Regulations for Construction*, sub-parts .651(b) and .416(a)(3) assign employers responsibility for identifying underground hazards and energized circuits near the work. The requirements of 29 CFR 1926.956(c) state that work must be conducted in a manner to avoid damage to underground facilities. Similarly, work must be performed in a manner that provides protection to the workers. DOE facility managers should review contractor safety guidelines to ensure compliance with OSHA standards.
